# Cavity Wall Construction

Take a historical journey of this building design concept's application in the commercial market from the 1930s to today.

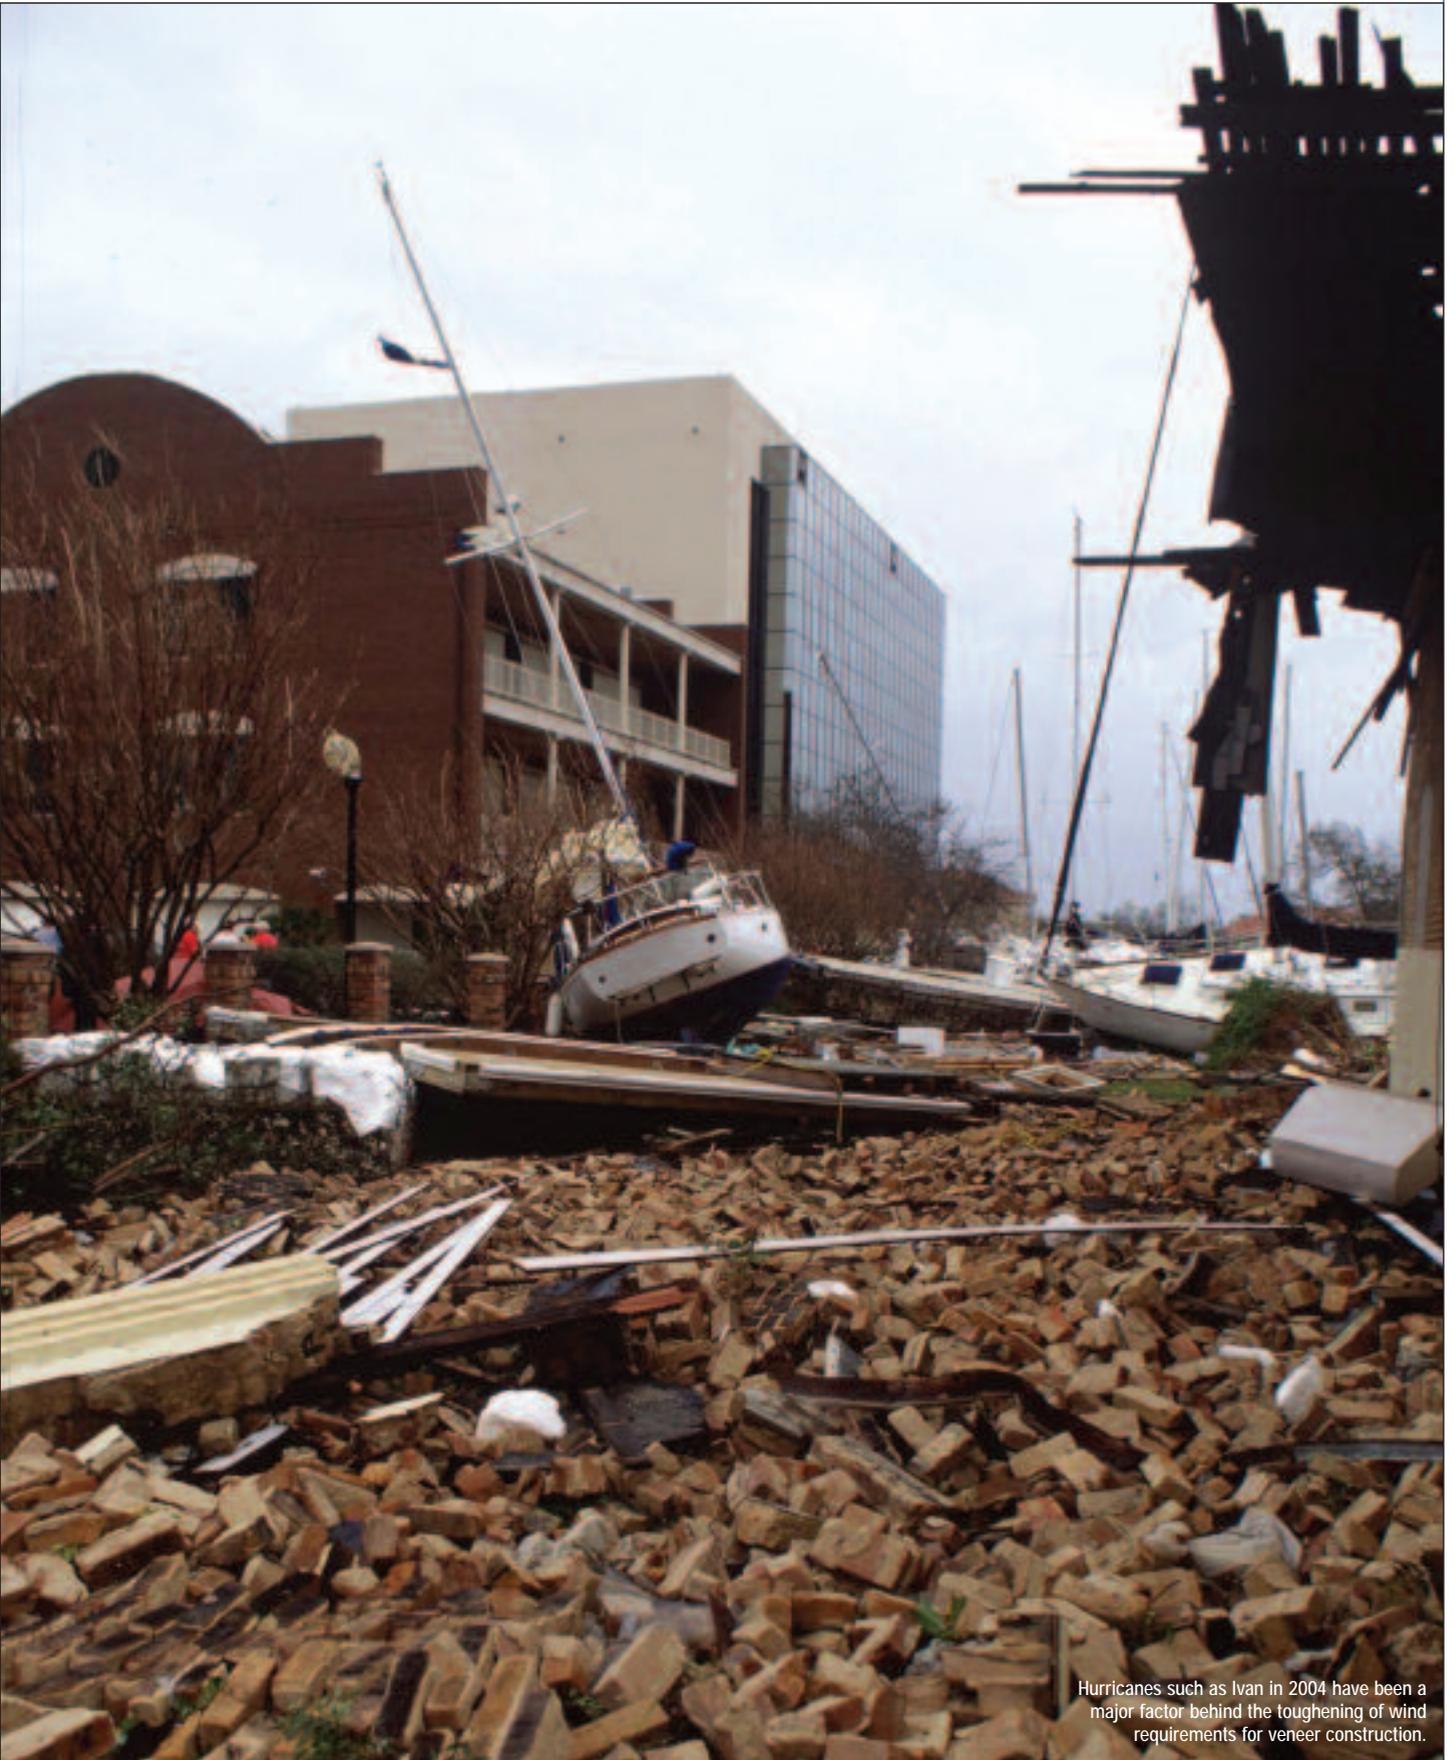
Hurricanes such as Ivan in 2004 have been a major factor behind the toughening of wind requirements for veneer construction.

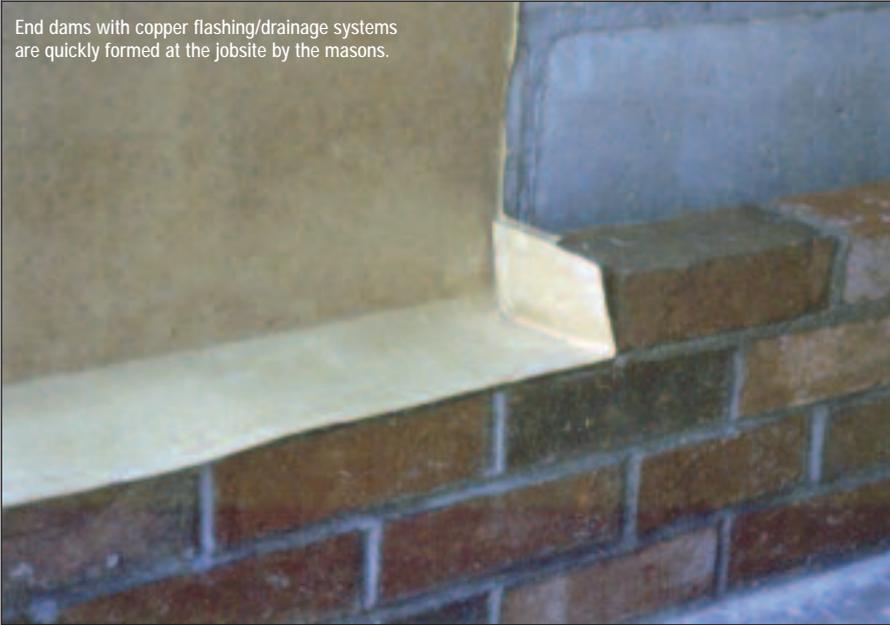
End dams with copper flashing/drainage systems are quickly formed at the jobsite by the masons.

Masons can field form end dams in less than one minute by using copper fabric. Attach the system with a termination bar and bed the flashing in the sealant bead. The wicking fabric eliminates the mortar deflection device and saves flashing height/cost and the increased code required wall tie criteria is more easily accommodated.

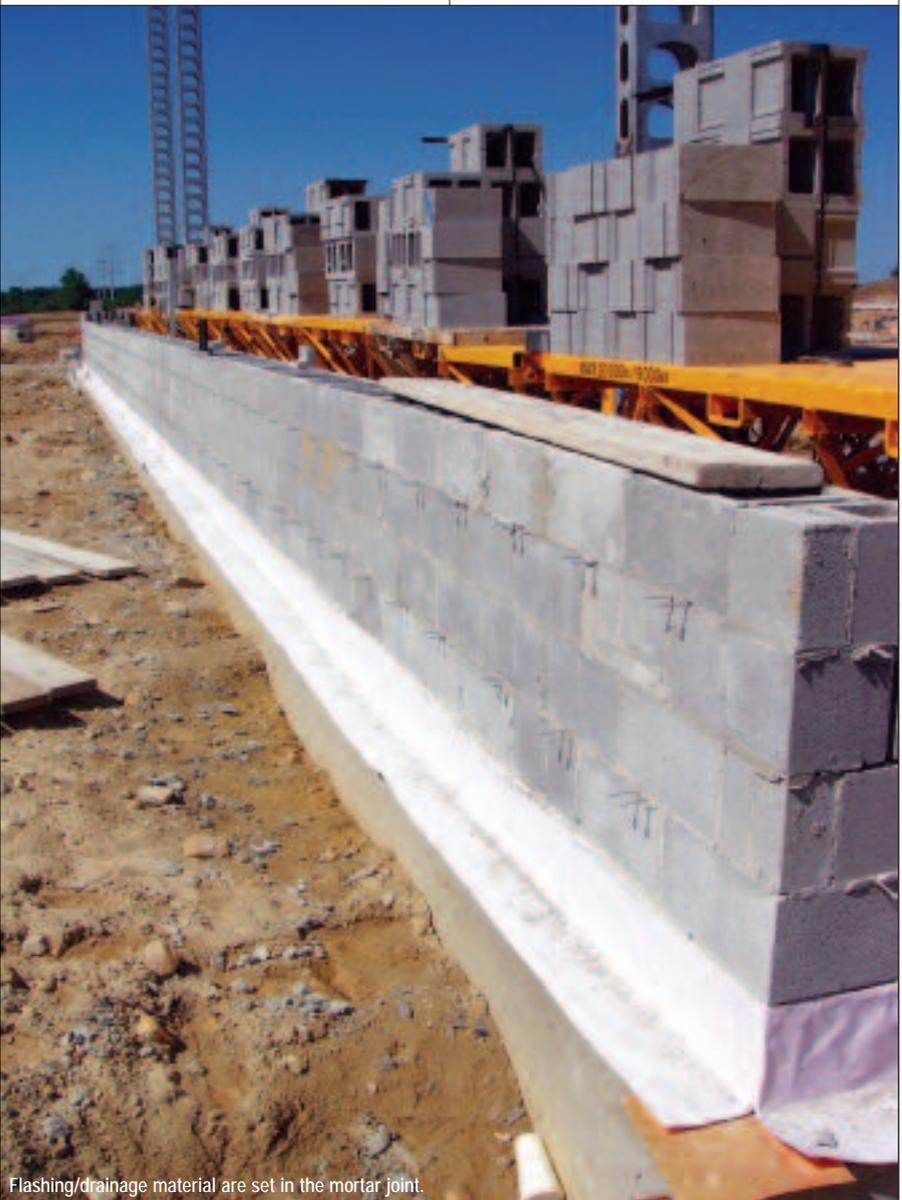
Flashing/drainage material are set in the mortar joint.

Still use time-tested dampproofing on masonry back-up, or 15-lb felt on steel stud/sheathing back-up. Avoid the mortar deflection device and save the additional 10+ inches of vertical height. Use material that combines the copper flashing with the laminated non-woven wicking fabric. The system is surface applied so the mason
